Mulkey-Monache Grazing Allotments, Golden Trout Wilderness
Head Cut and Photo Point Monitoring, 2003 and 2011 (DRAFT)

By: Casey Shannon, Hydrologic Technician
Inyo National Forest, Supervisor's Office
January, 2012

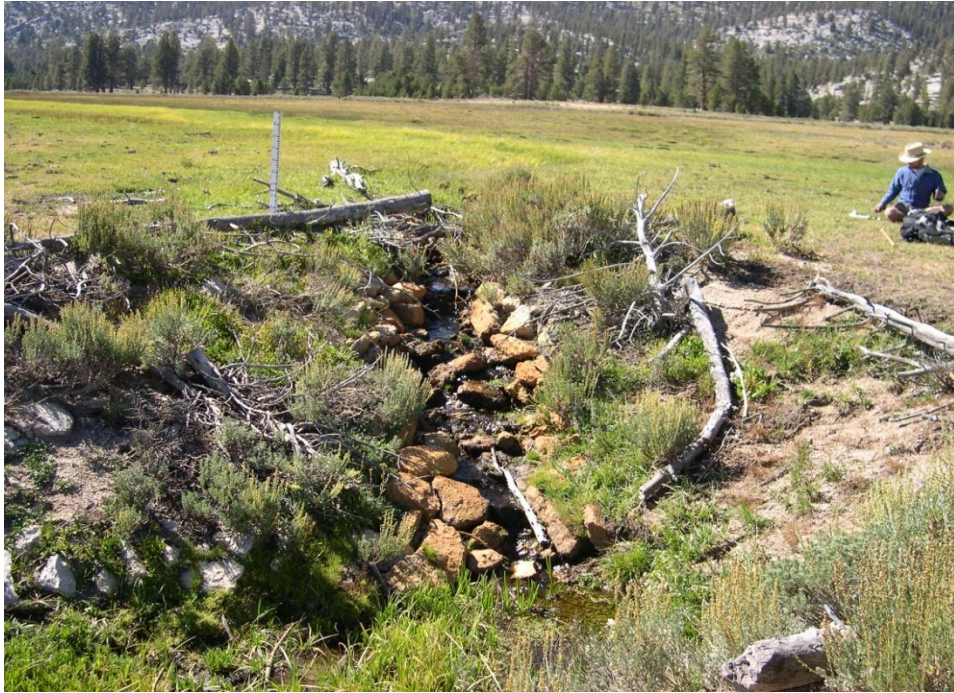
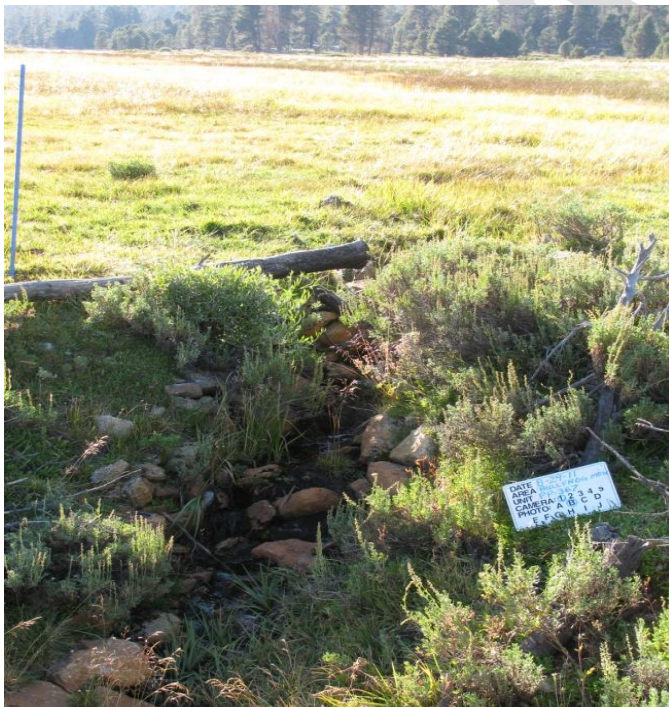
Above photo: Photo Point 367 (PP-367) Bullfrog Meadow, July 2003. PP-367 is a headcut located at the top of the incised gully in lower Bullfrog Meadow that was treated in the early 1990's with filter cloth and rock (rock chute armoring). Bare soil exists around perimeter of incision. **Below photo:** PP-367 with photo re-taken August, 2011. Bare soil shows an increase of vegetative cover and protection since 2003 and rock chute treatment is stable and effective. Gully bottom below rock chute is showing increases of riparian vegetation and appears to show a rise in elevation. Log armoring discourages cattle trampling on banks adjacent to rock chute.

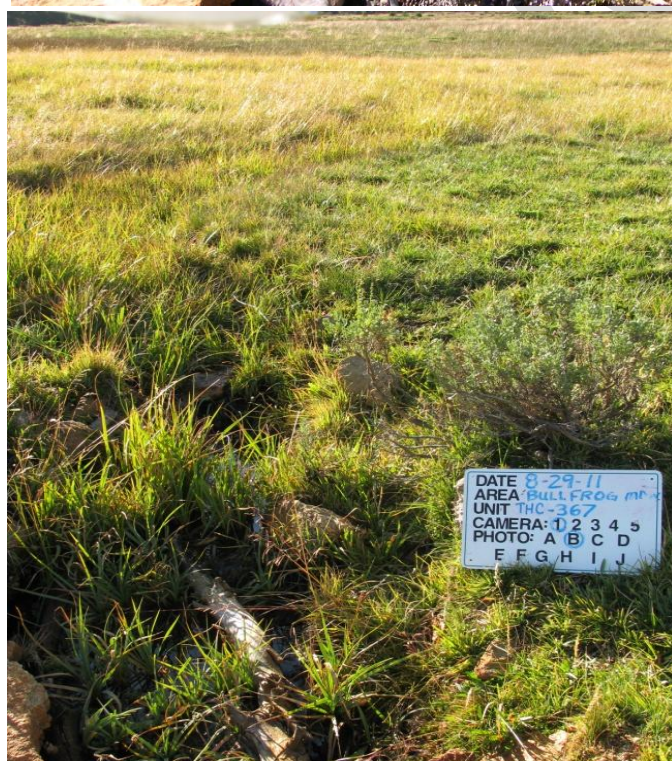
Above photo: Treated Head Cut 367 (THC-367) Bullfrog Meadow, July 2003. THC 367 is a head cut that was treated using filter cloth and rock chute armoring in the early 1990's adjacent to PP-367 (one of two once active headcuts at the top of the incised channel of Bullfrog Creek). **Below photo:** THC-367 Bullfrog Meadow photo re-taken August 2011. Rock chute has become vegetated, filled in with sod and stable, meeting prescription.

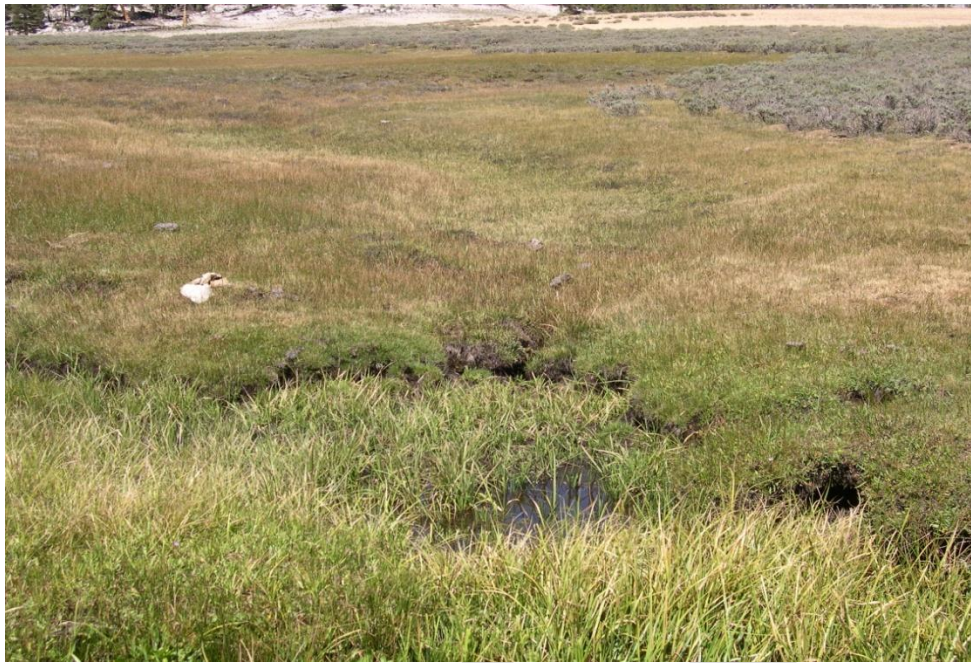
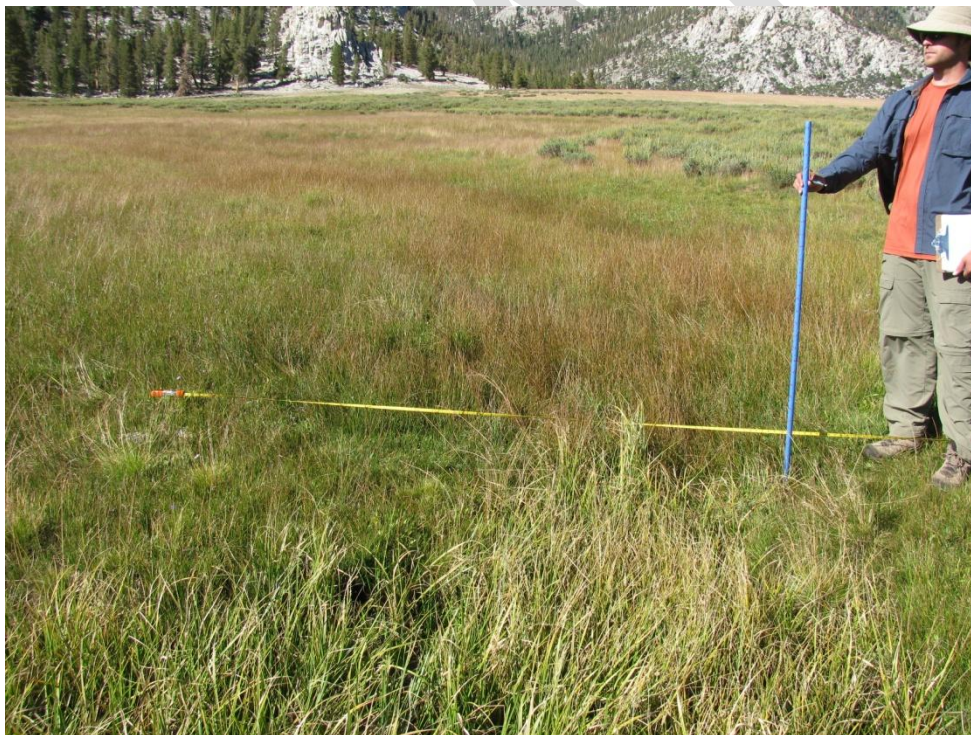
Above photo: Photo Point 364 (PP-364) Bullfrog Meadow, July 2003. Site is an active headcut and adjacent eroded banks on tributary of Bullfrog Creek. **Below photo:** PP-364 photo retaken August, 2011. Riparian vegetation has increased and filled in around head cut and banks have stabilized with only a small area of residual exposed soil existing. Site is showing an upward, stable trend. **NOTE:** PP-364 is also known as *Headcut 364* (HC-364). HC -364 has only moved 0.20 meters upstream since 2003 and likely is slowed by increased vegetation and stability at site.

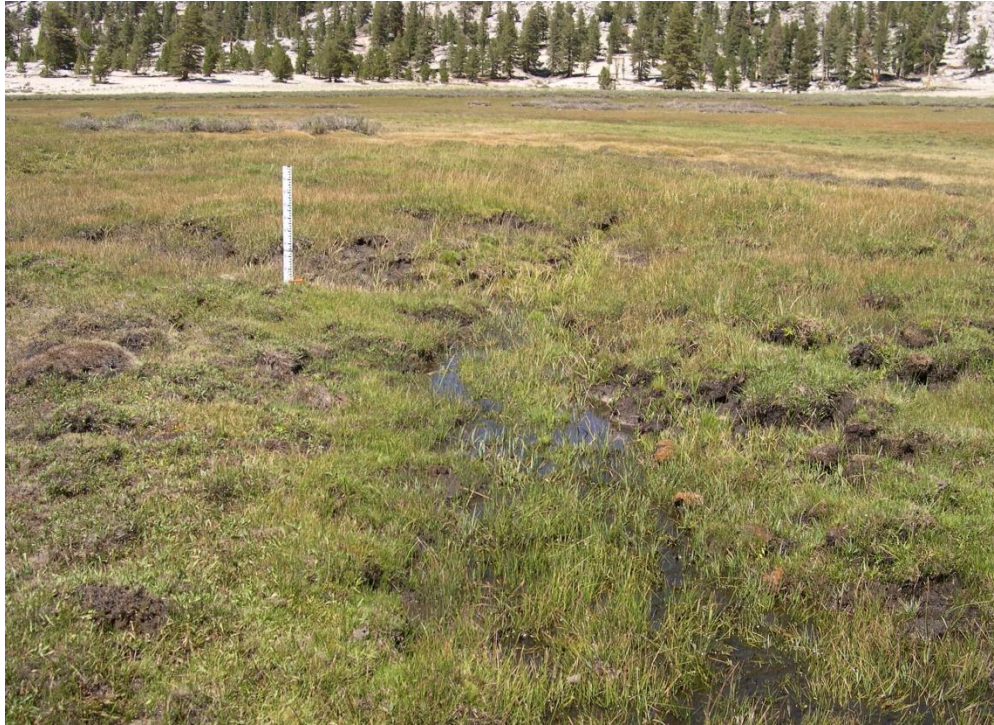
Above photo: Photo Point 365 (PP-365), Bullfrog Meadow photo taken July 2003. The site is an eroded wet meadow area with moderate hummock formations and pockets of exposed, partially eroded organic soil.

Below photo: PP-365 Bullfrog Meadow, photo re-taken August 2011. Hummock formations have lessened in scale and size although still present with less soil exposed. Riparian vegetation has filled in to a large degree over the site helping to stabilize fragile wet soil and the area of exposed soil has been significantly reduced. An upward trend exists at site.

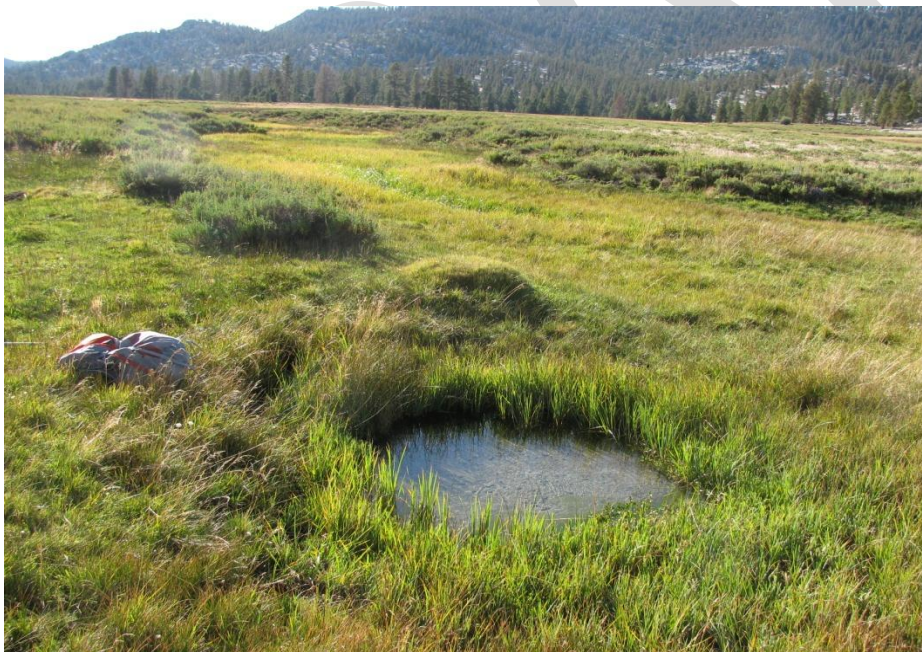
Above photo: Spring pool on south bank of Bullfrog Creek, Bullfrog Meadow August 2003. Algae content in pool obvious, floodplain of Bullfrog Creek in background. The banks around the spring pool are moderately impacted by grazing activity. Water quality appears to be adversely affected by nutrient loading. Three adult Mountain yellow legged frogs were seen in pool at this time. **Below photo:** Spring pool at Bullfrog Meadow photo re-taken August 2011. Banks are stable with robust vegetation and water quality appears to be improved, much less algae development. Floodplain vegetation along Bullfrog Creek channel is more robust and appears to be elevating towards terrace. Frogs were not present at this time of observation.

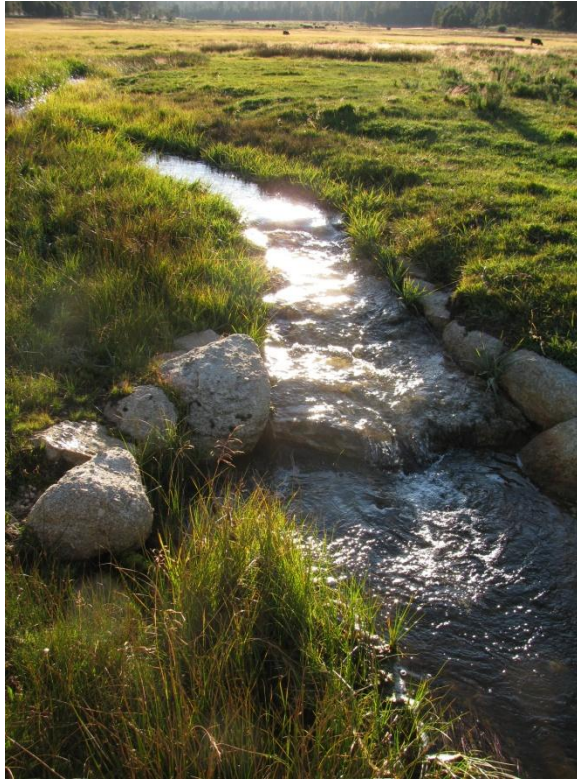
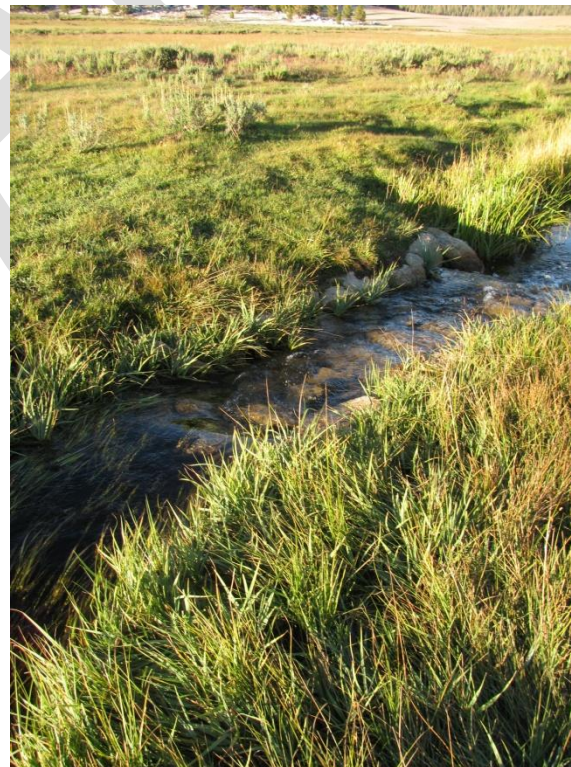
Above photo: 2010 treated head cut in Bullfrog Creek channel (rock and filter cloth armoring). Treatment maintained effectiveness after high runoff from snow melt and intense summer rain event. **Below photo:** 2010 treated head cut looking down stream, sod banks are growing into structure providing stability.

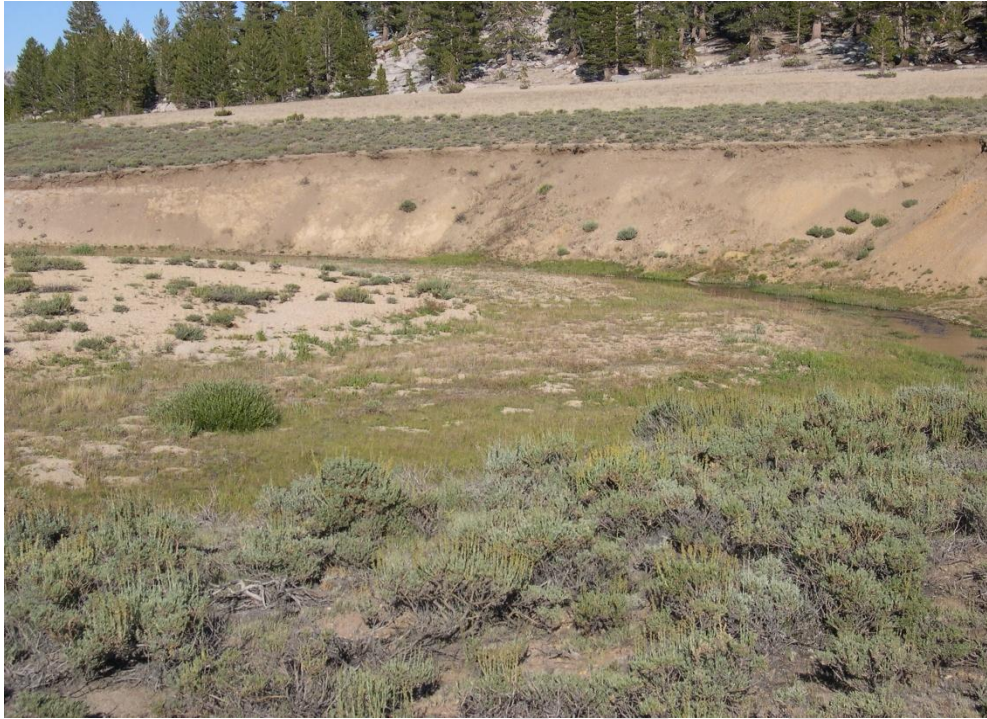
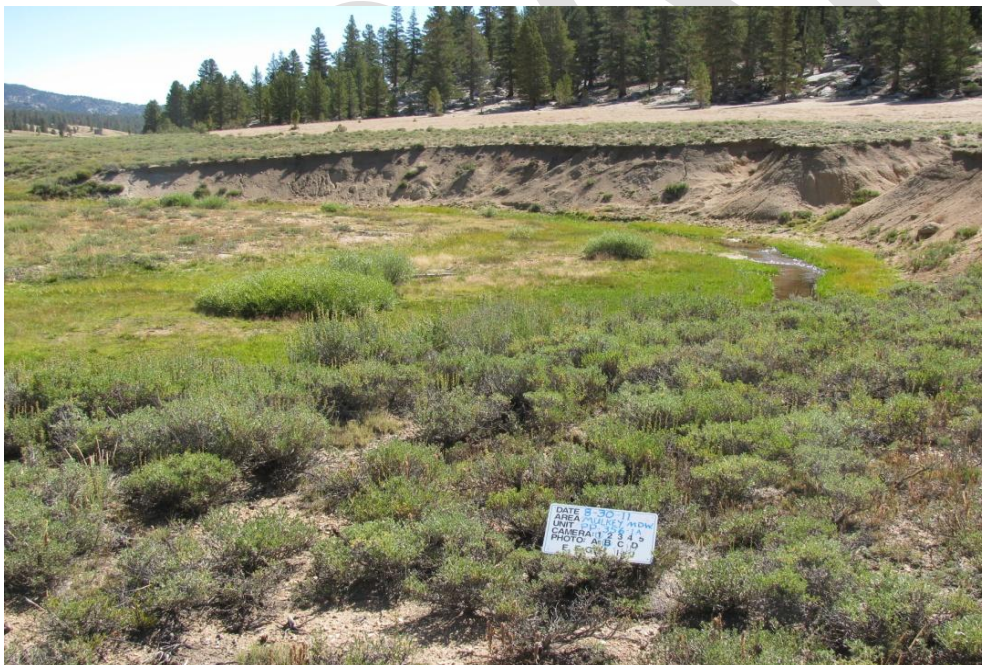
Above photo: Photo-point 356 1-A (PP-356-1A), Mulkey Meadow looking east up stream, July 2003. Replicate of La Barbara photo of 1991. Site is a wide meander bend of Mulkey Creek flowing and cutting into a large alluvial deposit. Stream channel is lined with lighter density vegetation and adjacent point bar is mostly bare with recent deposition. **Below photo:** Same site with photo retaken August 2011. Point bar vegetation cover increased, channel has narrowed and established in the bottom, willow growth has increased. Stream appears to not be moving further into bank.

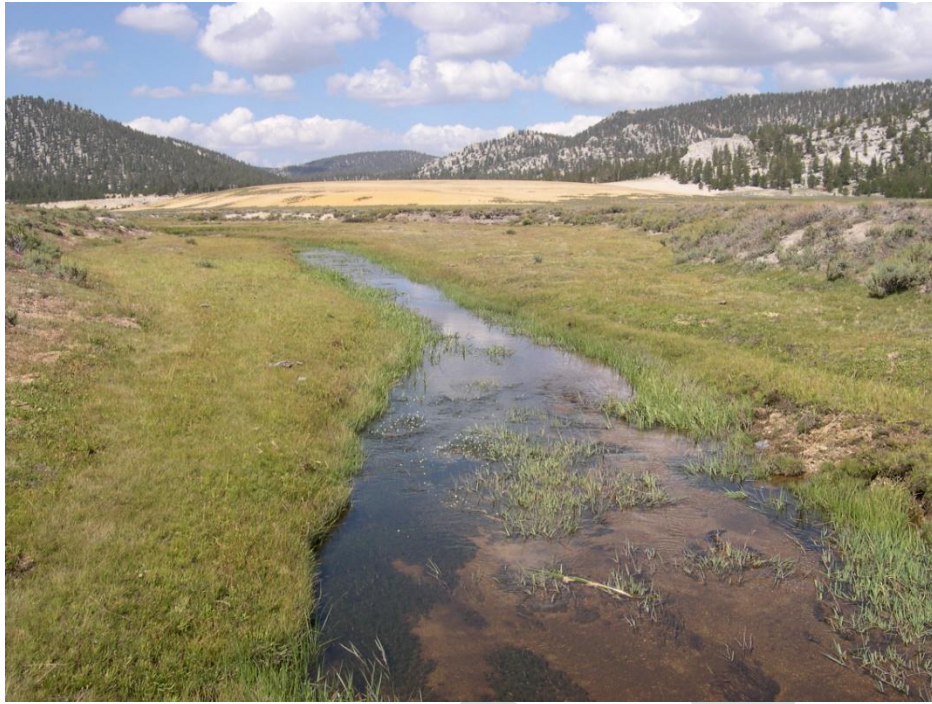
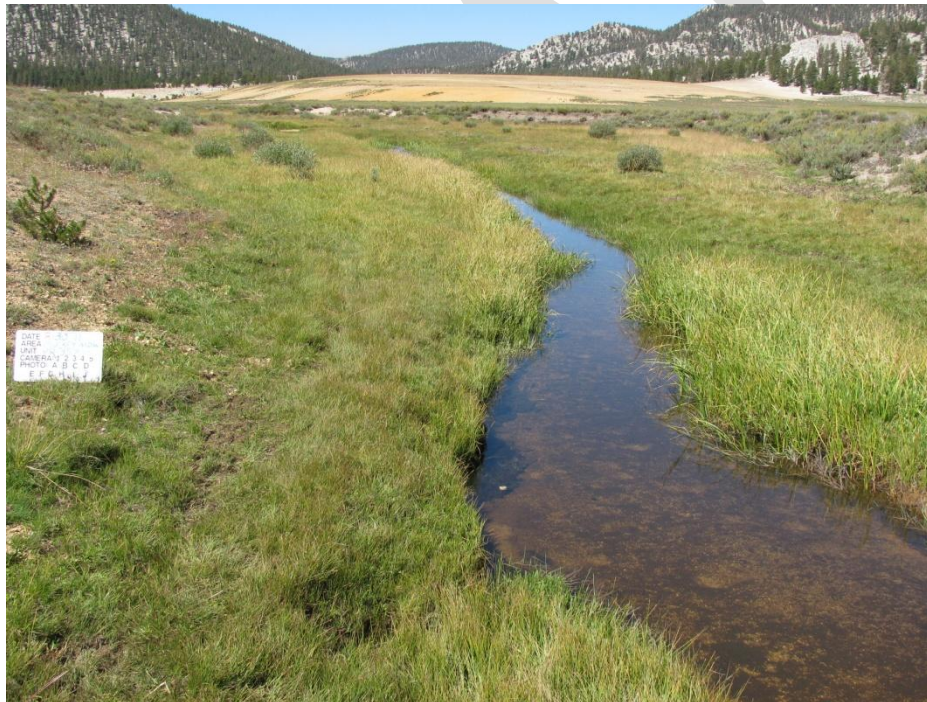
Above photo: Photo-point 357-1A (PP-357-1A), Mulkey Meadows, August 2003. Site is a mostly straight reach of stream (Mulkey Creek) within an old, incised channel and adjacent terraces with recovering floodplain. Stream channel at this time appears to be over widened (poor width to depth ratio for this stream type). **Below photo:** Same site with photo retaken August 2011. The stream channel is narrowing and stream bank vegetation is more robust, channel is trending closer to normal width to depth ratio. Floodplain vegetation has increased, willow recruitment is occurring along floodplain. Vegetative cover along stream banks has improved. Site is a repeat of La Barbara 1991 photo.

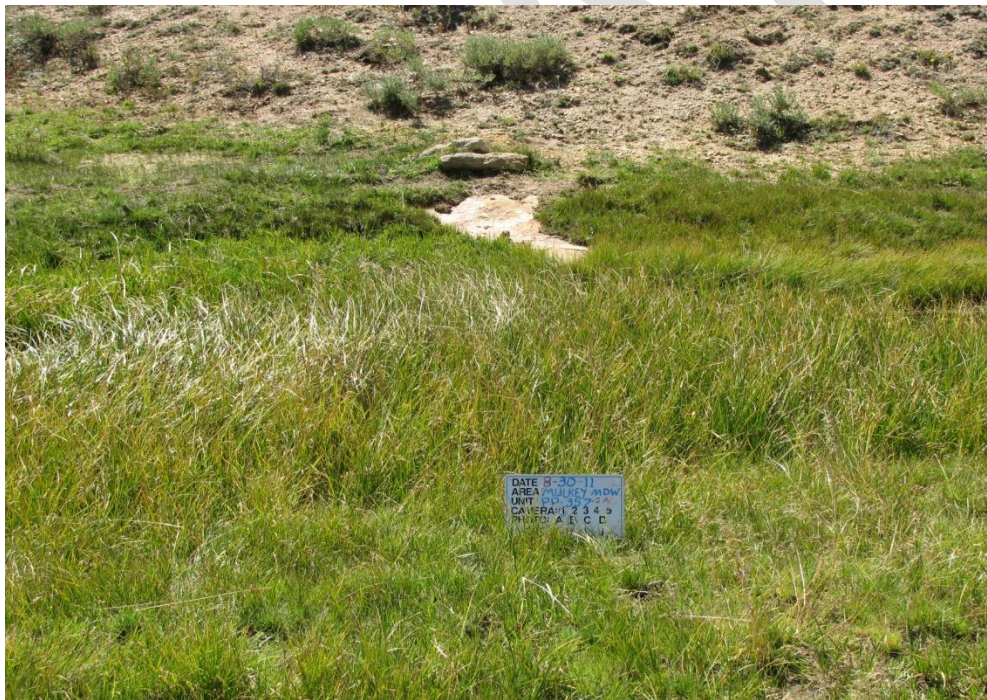
Above photo: Photo taken July 2003, Photo-point 357-2A (PP-357-2A), Mulkey Meadows looking across channel bottom cross section on Mulkey Creek. Sod layer along stream banks is fragmented with bare soil areas. Riparian vegetation density is moderate at site and stream channel is over-widened. **Below photo:** Photo-point 357-2A with photo retaken August 2011. Streamside vegetation has increased and is much denser in coverage, improving hydrologic function. Stream channel has narrowed and banks are stable. Site is a repeat of La Barbara photo 1991.

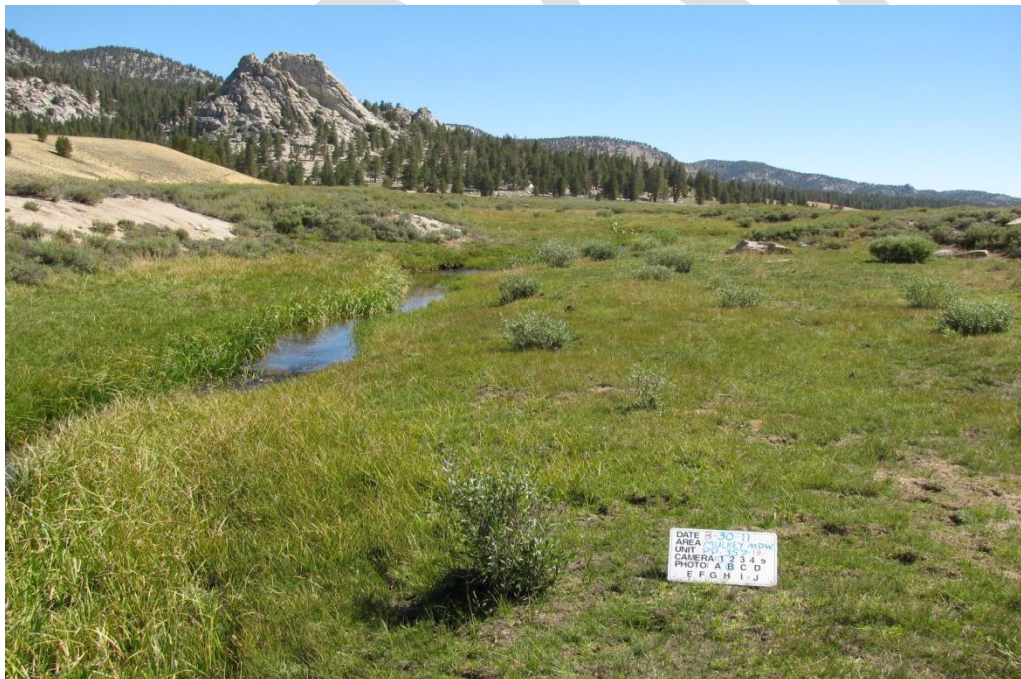
Above photo: Photo-point 357-1B (PP-357-1B), Mulkey Meadow along Mulkey Creek, August 2003. Site is a straight reach looking along stream side flood plain and channel. Some bank erosion is noticeable in foreground.

Below photo: Same site with photo retaken August 2011, Riparian vegetation along stream channel has increased and stream banks are more stable, willow recruitment is apparent. Slight upward movement of riparian vegetation growth on terrace slopes is noticeable. Site is a repeat of La Barbara 1991 photo.

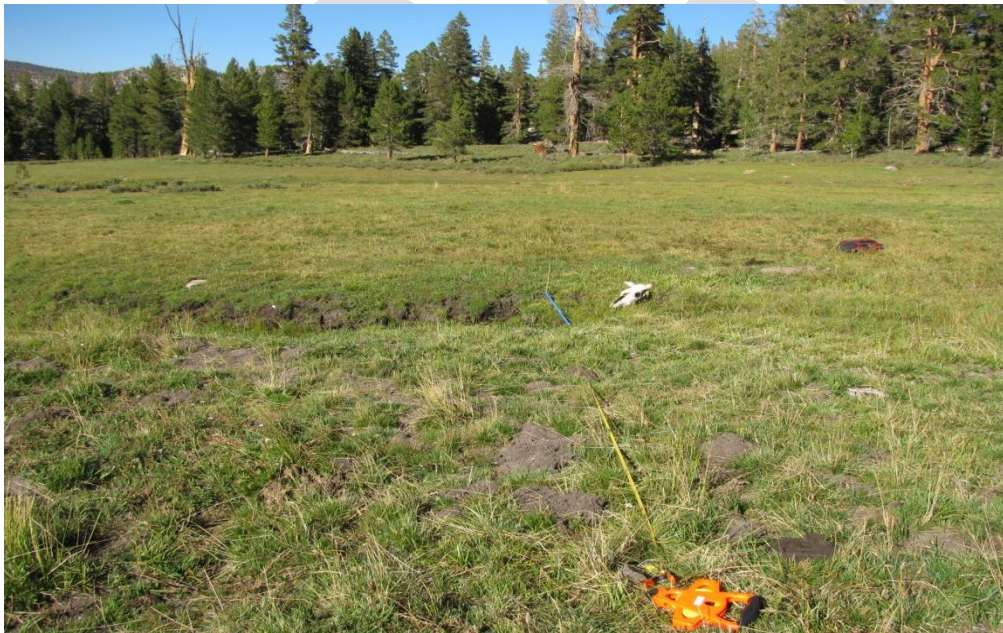
Above photo: Head Cut 359 (HC-359) Bear Meadow, August 2003 looking across top of headcut (transect tape crosses HC face). Moderate sized gully exists below HC, gully banks show exposed soil along gully edges. **Below photo:** HC 359 Bear meadow with photo re-taken August 2011. HC has migrated 0.60 meters since 2003 a cow skull is seen at the current HC location. Migration is slow due to a resilient, well developed sod layer and strong vegetation rooting into deep organic soil. Gully banks below HC show increased soil erosion and bare soil. Gopher activity noticeable, overall sod layer in meadow appears same, not full. HC has right conditions for stabilization.

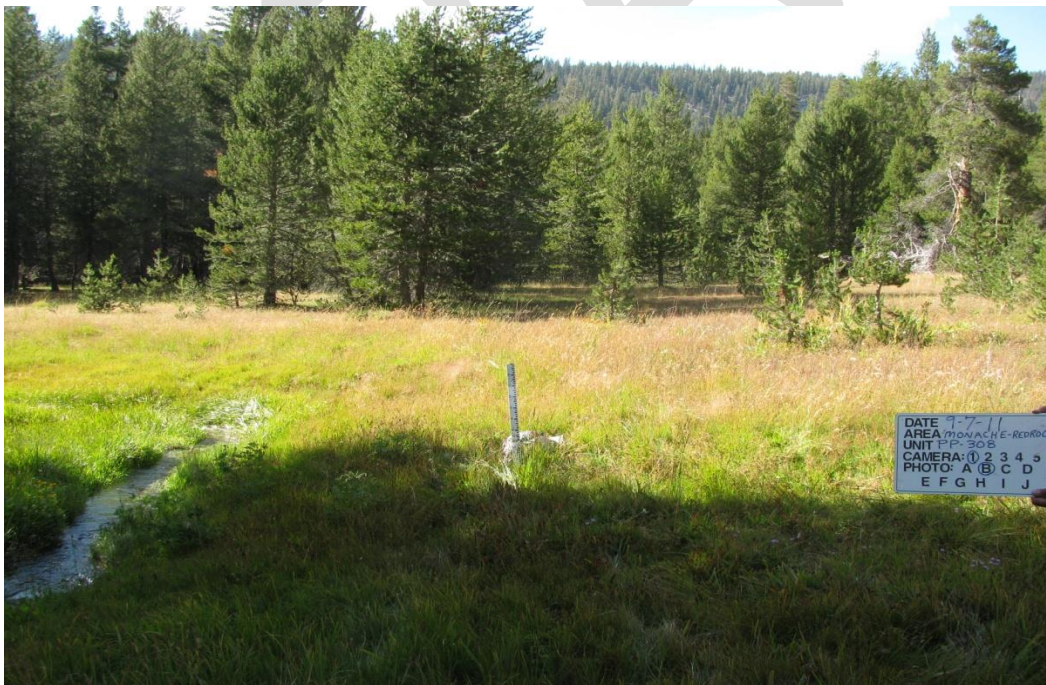
Above photo: Photo-point 308 (PP-308) Redrock Meadow, June 2003. Site is an area of punctured sod and partially exposed soil on the banks of east branch of Redrock Creek. **Below photo:** PP-308 with photo re-taken September, 2011. Most of the disturbed sod areas have re-vegetated, riparian vegetation is more robust and the site is stable.

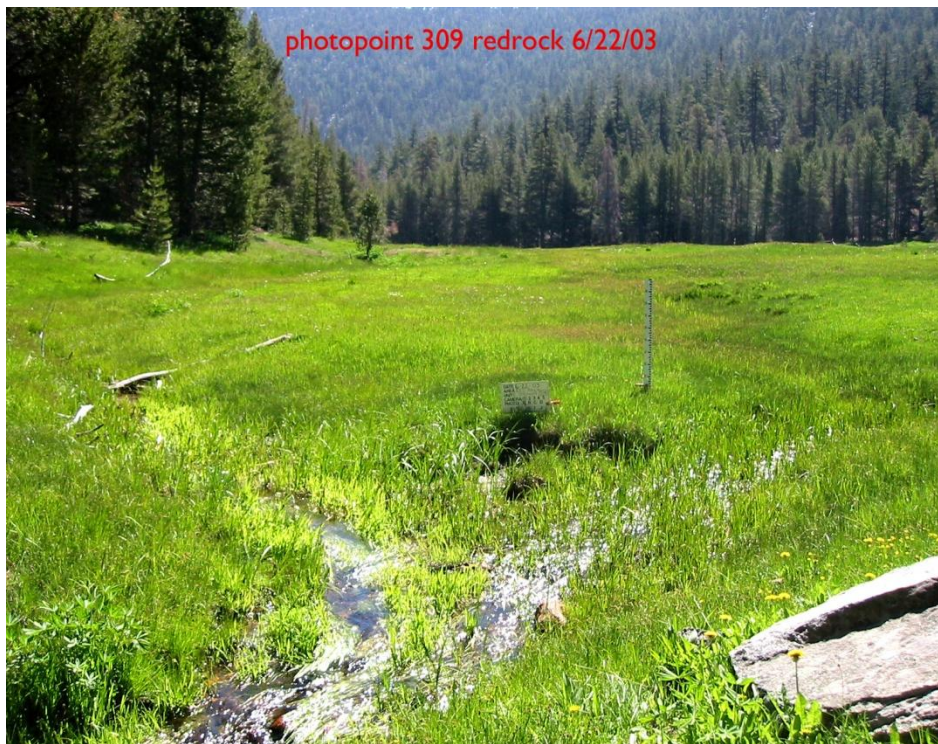
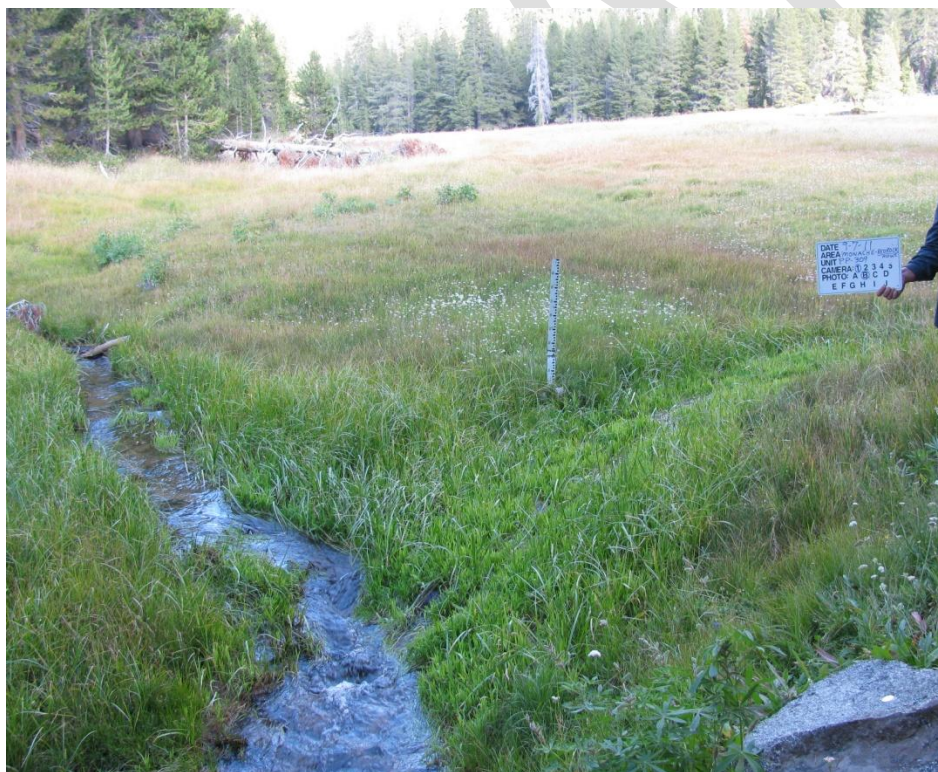
Above photo: Photo-point 309 (PP-309) Redrocks Meadow, June 2003. Site is a disturbed and eroded stream bank at the confluence of two stringers, in mid photo. **Below photo:** PP-309, with photo re-taken September 2001. The eroded stream bank is now fully stabilized with new riparian vegetation growth. Stream channel has narrowed and deepened.

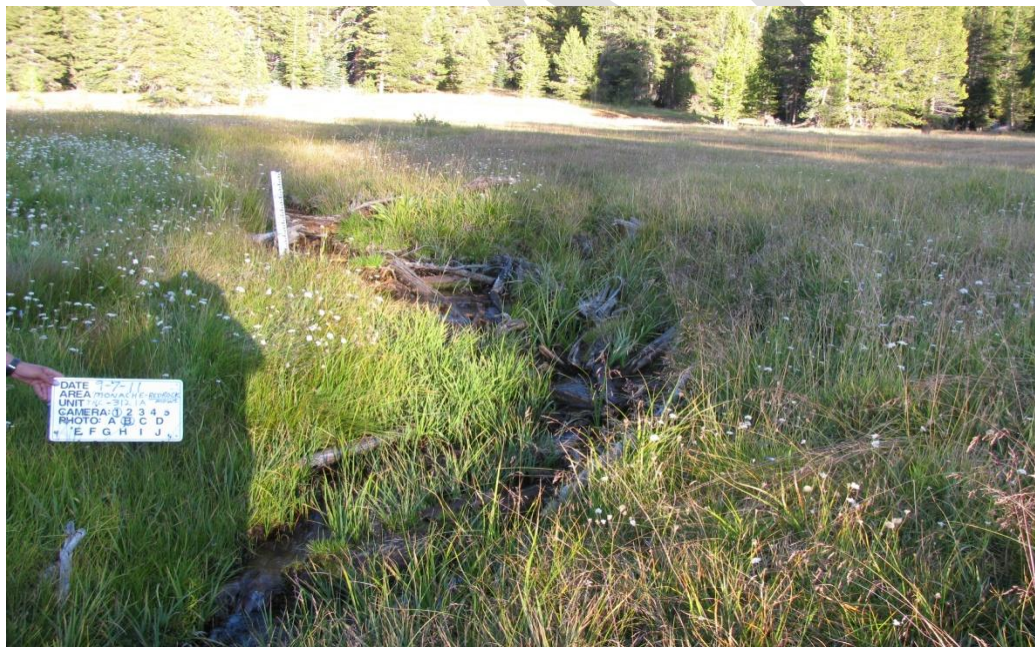
Above photo: Treated Head Cut 312-1A (THC-312-2a) Redrock Meadow, photo taken June 2003. Site is a channel with a series of small headcuts treated with limbs/branches placed over headcuts to slow erosion and to discourage cattle trampling. Stream bank edges are showing moderate erosion. **Below photo:** THC-312-1A with photo re taken September 2011. Bare soil areas on banks have re-vegetated, the channel has narrowed and woody materials have become structured into the soil and vegetation.

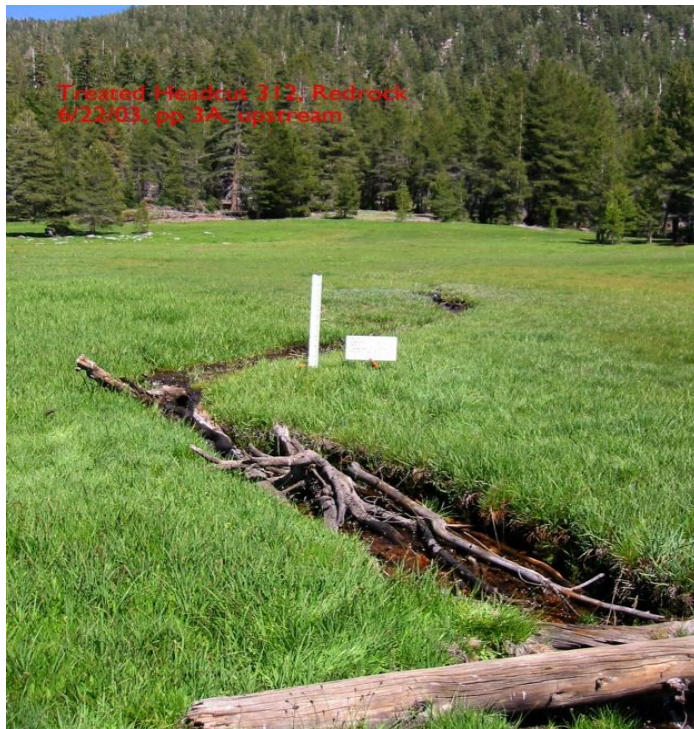
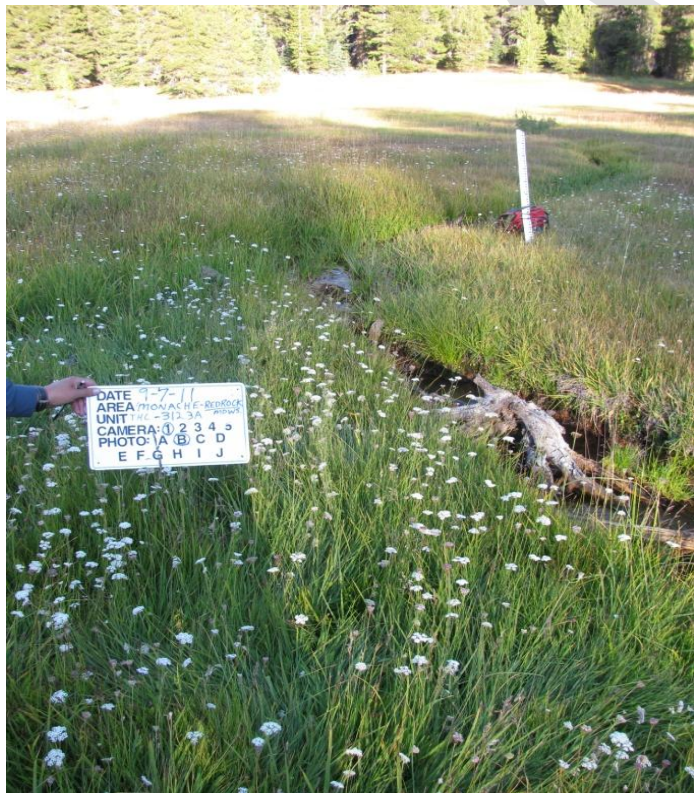
Above photo Treated Head cut 312-3A (THC-312-3A) Redrock Meadow, June 2003. Head cut treated has slowed head cutting, stream banks have over widened and are showing areas of bare soil. **Below photo:** THC-312-3A with photo re taken September, 2011. Stream banks have narrowed and stabilized with robust vegetation and erosion rates are low to normal.

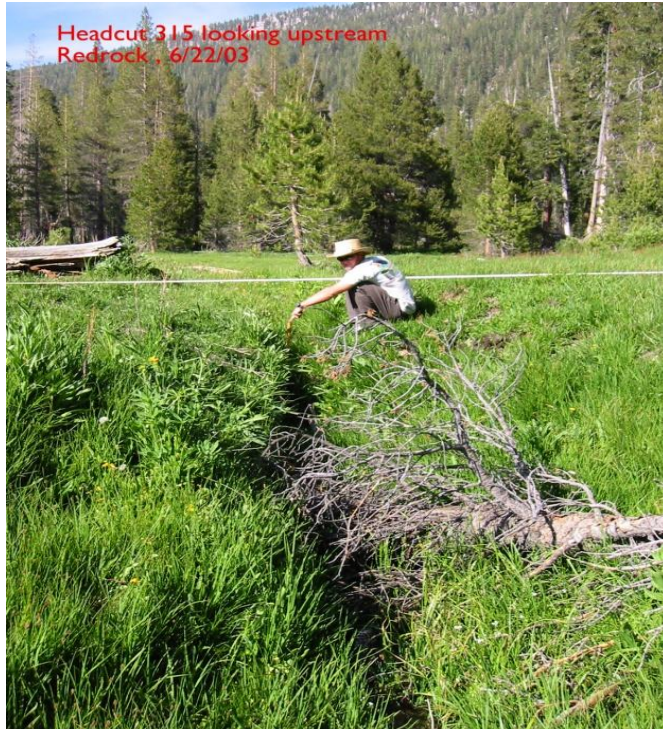
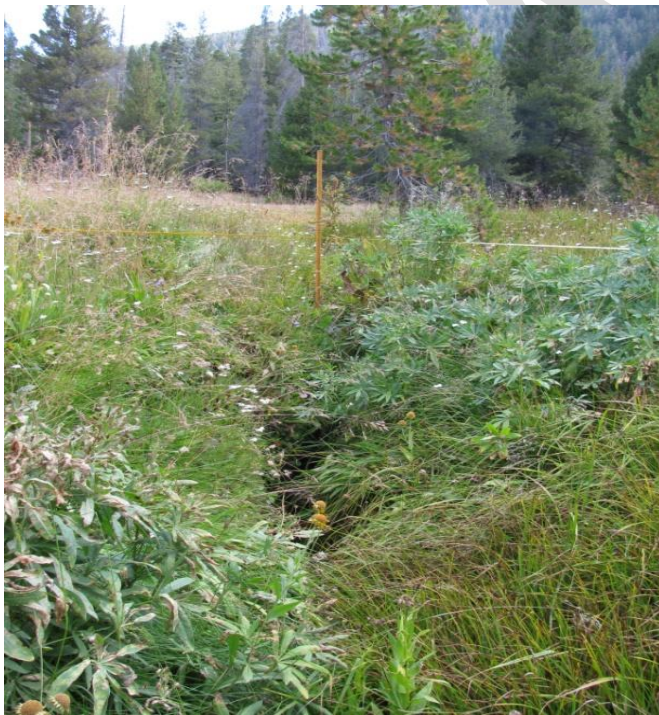
Above photo: Head Cut 315 (HC-315), Redrock Meadow with photo taken June 2003. The site is a steep headcut with a deep and narrow channel. Banks are mostly stable with well-developed vegetation. **Below photo:** HC-315, Redrock Meadow with photo re taken September 2011. Head cut had migrated only 0.35 meter, indicating a stable site. The headcut has a deep fall (face) and has a higher scour factor but dense, well rooted vegetation along the banks and a cobble dominated stream substrate resist erosion. Likely this HC will not migrate to any severe amount. Site would be very suitable for treatment (low priority) good resources nearby for treatment.

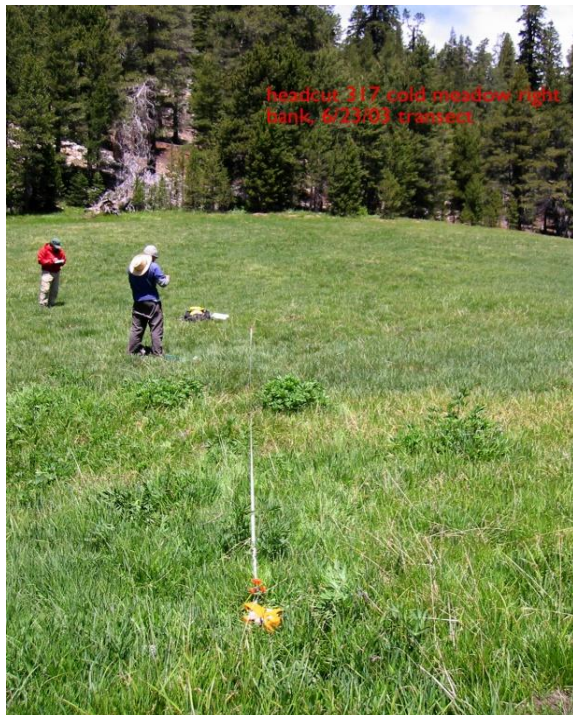
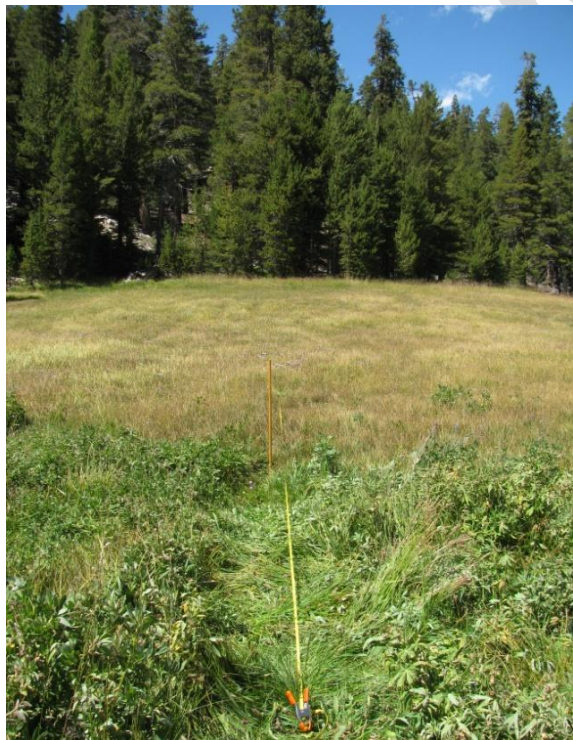
Above photo: Head cut 317 (HC-317) Cold Meadow June 2003. View is looking across transect from right bank to left bank. **Below photo:** HC-317 Cold Meadow with same photo re-taken September, 2011. Head cut has migrated only 0.30 meter, clay type sub soil below "A" horizon and dense vegetation has slowed erosion rates. This site is suitable for HC treatment.

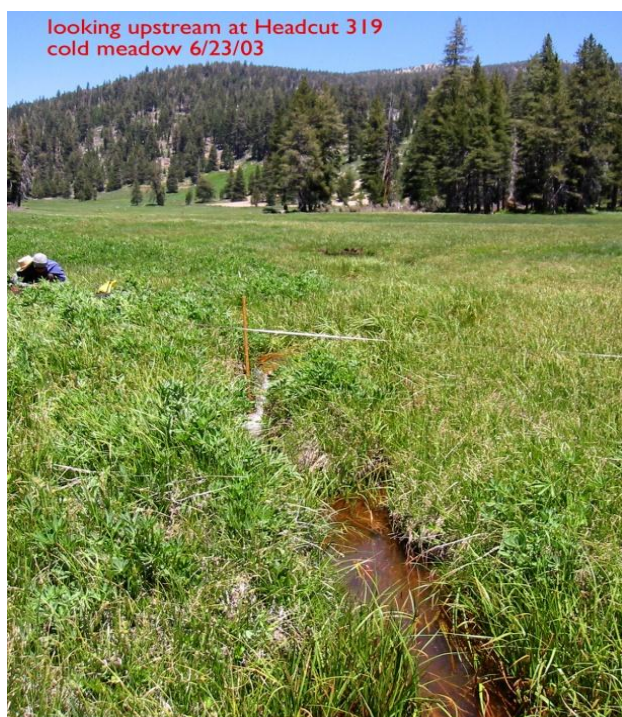
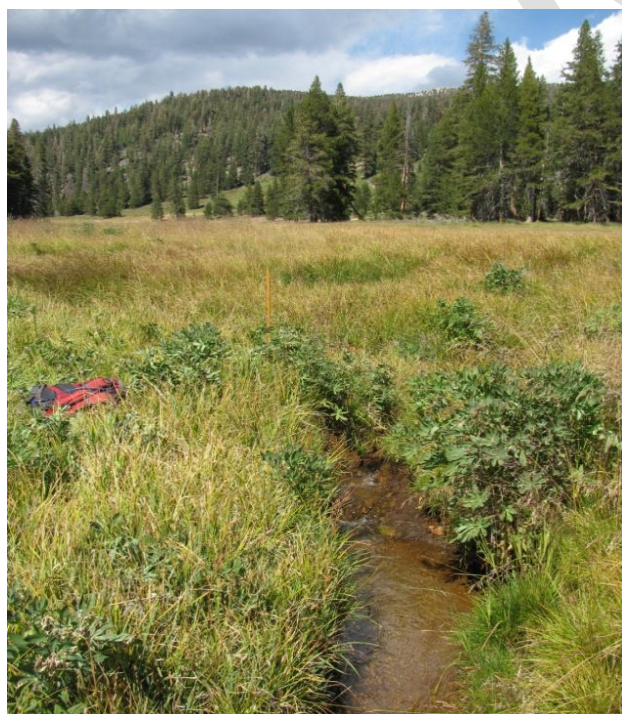
Above photo: Head cut 319 (HC-319) Cold Meadow June 2003. View is looking up channel at head cut and transect in narrow channel. **Below photo:** HC-319 Cold Meadow with photo re-taken September 2011. Due to aggressive vegetative growth at the site the head cut transect monuments could not be relocated (did not have metal detector). Site was estimated referring to 2003 photo to see if migration occurred and an estimated 3.9 meters of migration occurred. Head cut is still active and is suitable for treatment with excellent sod layer and stability at the site.
